**5. PARKING PROPOSALS - MAIN ROAD**

**PURPOSE OF REPORT**

1. The purpose of this report is to seek the Board’s approval for the installation of “no stopping” restrictions on the Estuary side of Main Road between Scott park and the west culvert.

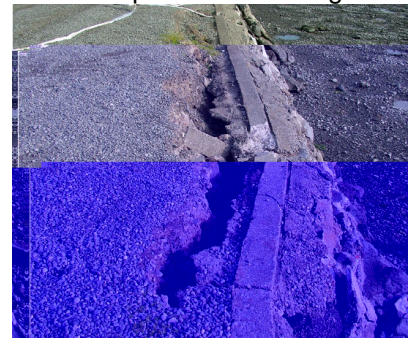
3. The Estuary seawall is a continuous structure, approximately 1,700 metres long, constructed of large angular stones and concrete blocks held together by unreinforced concrete and mortar. A visual inspection has found many areas of the Estuary seawall in need of repair. The area of repair is contained in the first 1,000 metres from Scott Park to the west culvert at the start of the Causeway. The balance of the Estuary seawall to Beachville Road is in reasonable condition and does not pose a risk at this time.

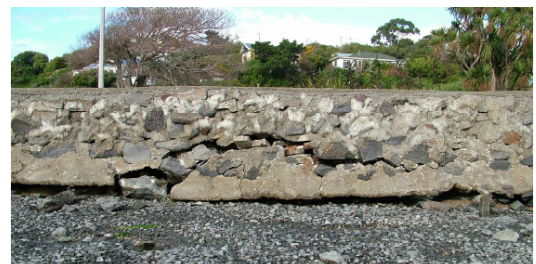
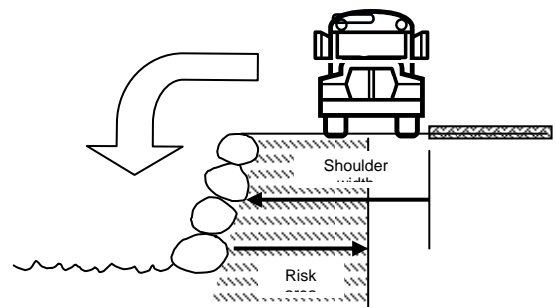
4. The cause of the damage to the Estuary seawall is foreshore erosion. This erosion has undercut the wall and has led to the damage and risk to the seawall and shoulder. Parts of the Estuary seawall have cracked and slumped due to the erosion and this has created instability in the road shoulder with visible signs of surface cracks and subsidence behind the wall.

The unknown factor is if any large voids or cavities exist below the surface of the road shoulder. The risk here is to vehicles that break the surface and become trapped. The analogy that springs to mind is ‘walking on egg shells’ and the risk of vehicles breaking the ‘shell’ can be reduced through a parking restriction. The seawall itself is at risk where the erosion has undercut the base of the seawall. This has made it unstable and it is now susceptible to a side force that will tip the wall over. Heavy vehicles exert a sideways force that is capable of pushing the wall over and it is for this reason that the parking restriction for heavy vehicles is recommended for the section from McCormacks Bay Road (west) to the west culvert. Light vehicles do not pose a risk as the force exerted is considerably less and not sufficient to tip the wall.

**Option 2 (preferred)**- Put in place parking restrictions in the area of greatest risk - between Scott Park and the west culvert 400 metres east of McCormacks Bay Road (west). The section of road from Scott Park to McCormacks Bay Road currently has a section of "no stopping" and it is proposed to "fill in the gaps", a length of approximately 190 metres with more "no stopping" lines. From McCormacks Bay Road (west) to the west culvert it is proposed to prohibit the parking of heavy vehicles only for a length of 420 metres (see attachment). The cost of this option is \$1,200.
