MEMO

To: Mayor and Councillors
From: Liveable City Programme Manager
CC: General Manager Regulation and Democracy Services
Date: 5 October 2010
Re: Council meeting 6 October 2010: Additional information to accompany heritage reports

GPR Survey 160 Manchester Street

Ground Penetrating Radar (GPR) Survey

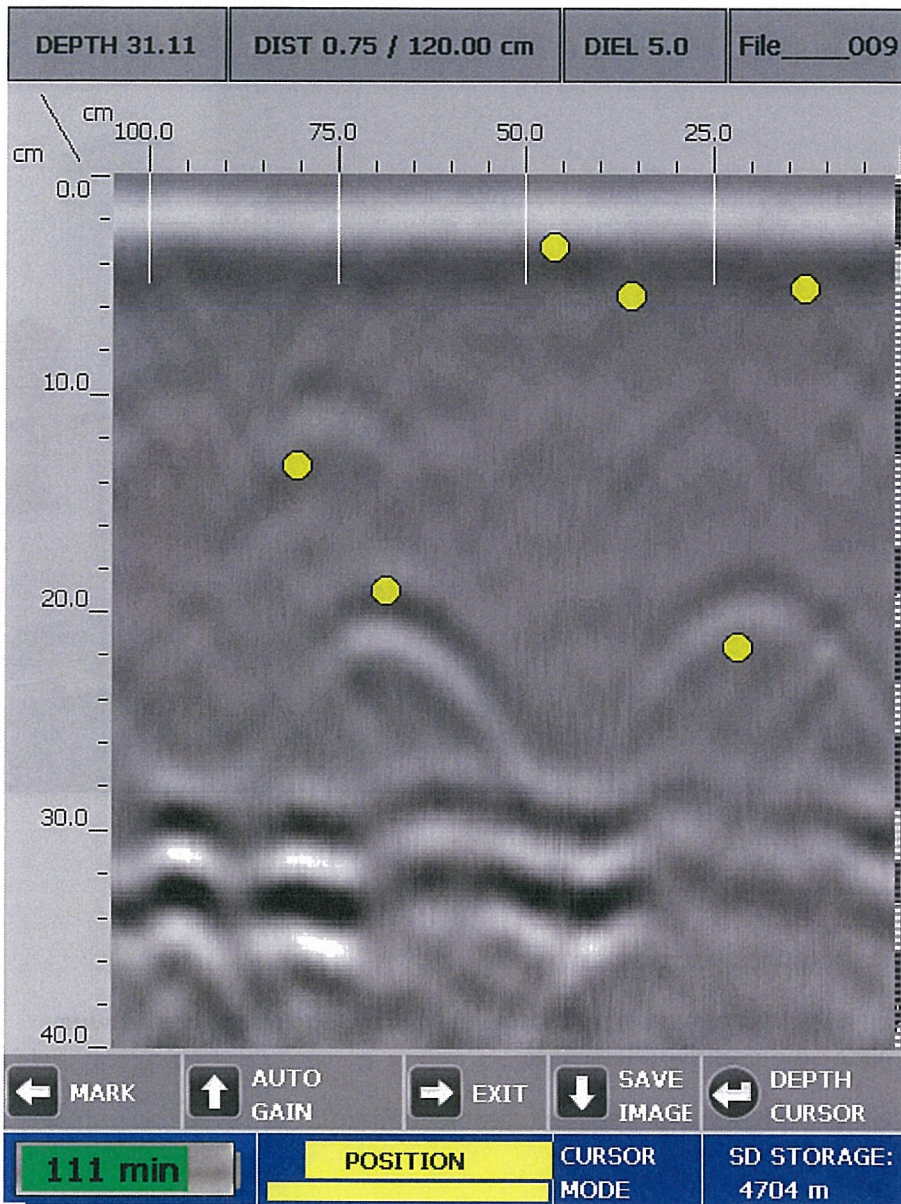
The East wall differs in construction to the North and West walls as it has a full brick face from Floor 3 through to Floor 7. Images 1 and 2 illustrate the targets within the wall.

Image 2. East Wall Vertical – showing internal wall lining at the bottom around 300mm

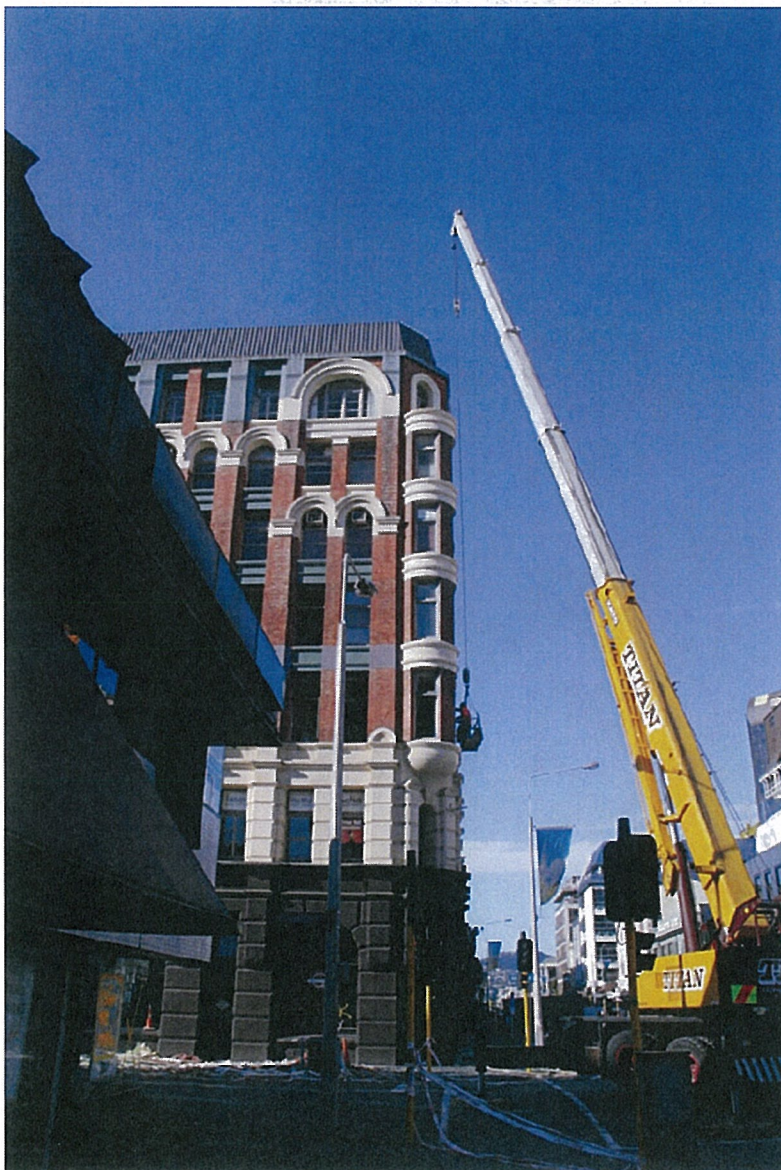
Image 4. Crane positioned in intersection.

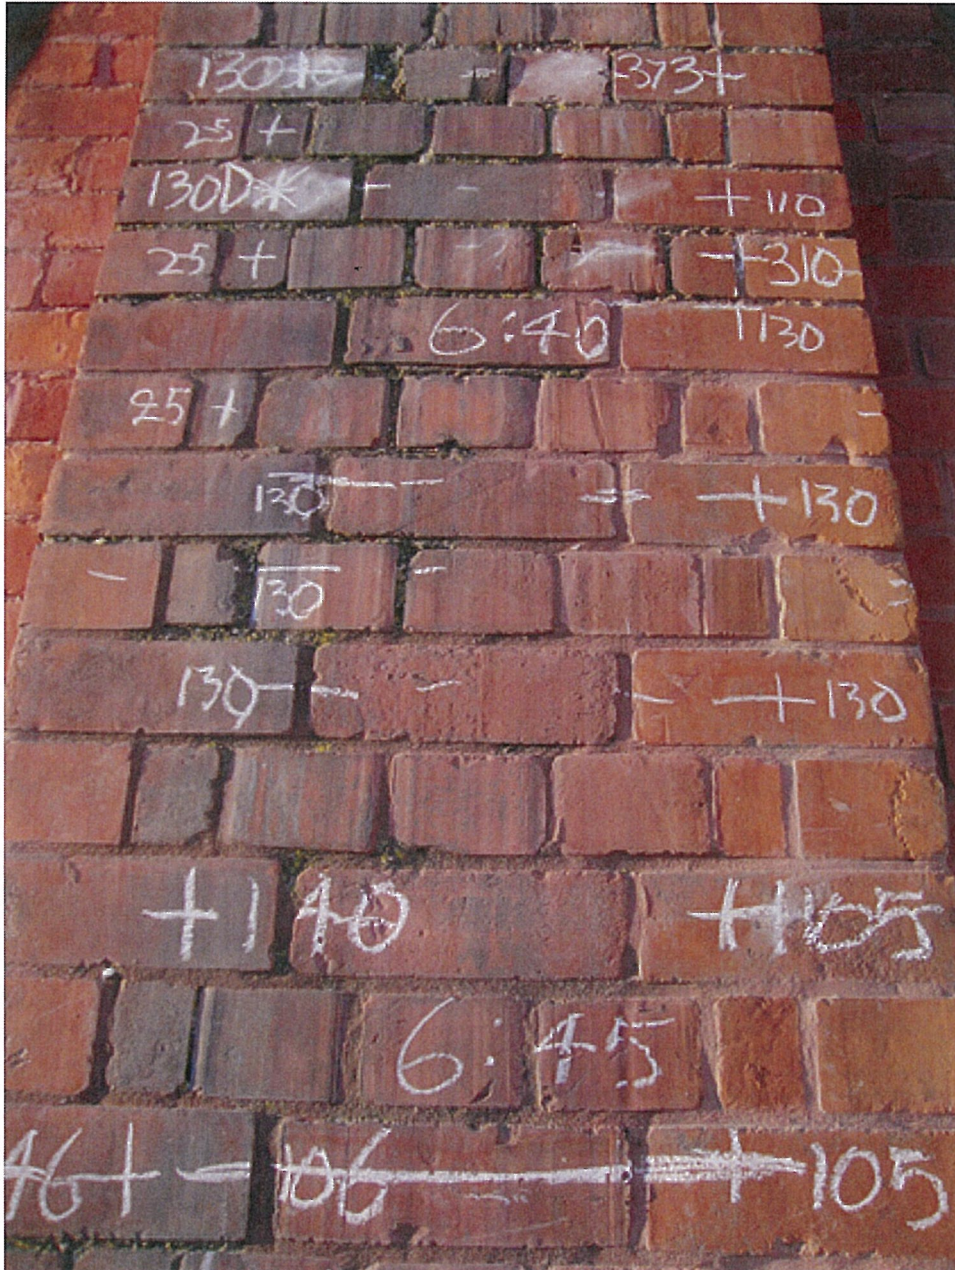
Photo 2: Marking of column on North face. (Time reference 7:15)

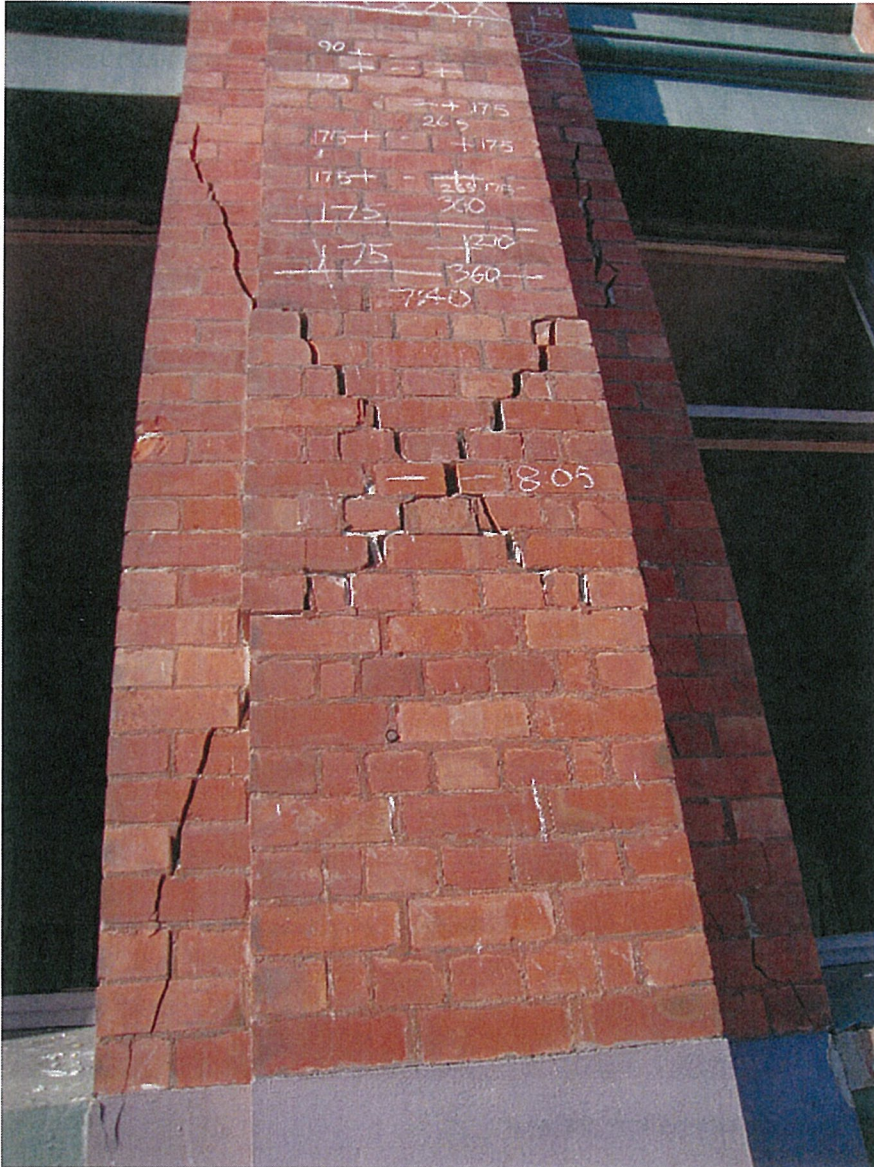
One of the columns on the North face exhibits a large crucifix type deep crack. Image 2 is the survey image taken across the crack running vertically, the crack centre being marked with a 'X'. In looking through the crack openings, it was possible to confirm at least a triple brick construction of the outer part of the column. There is a possibility of some kind of steel reinforcing in the centre closer to the interior wall, however this could not be verified by GPR.

Image 8. Crucifix crack in column, North face.

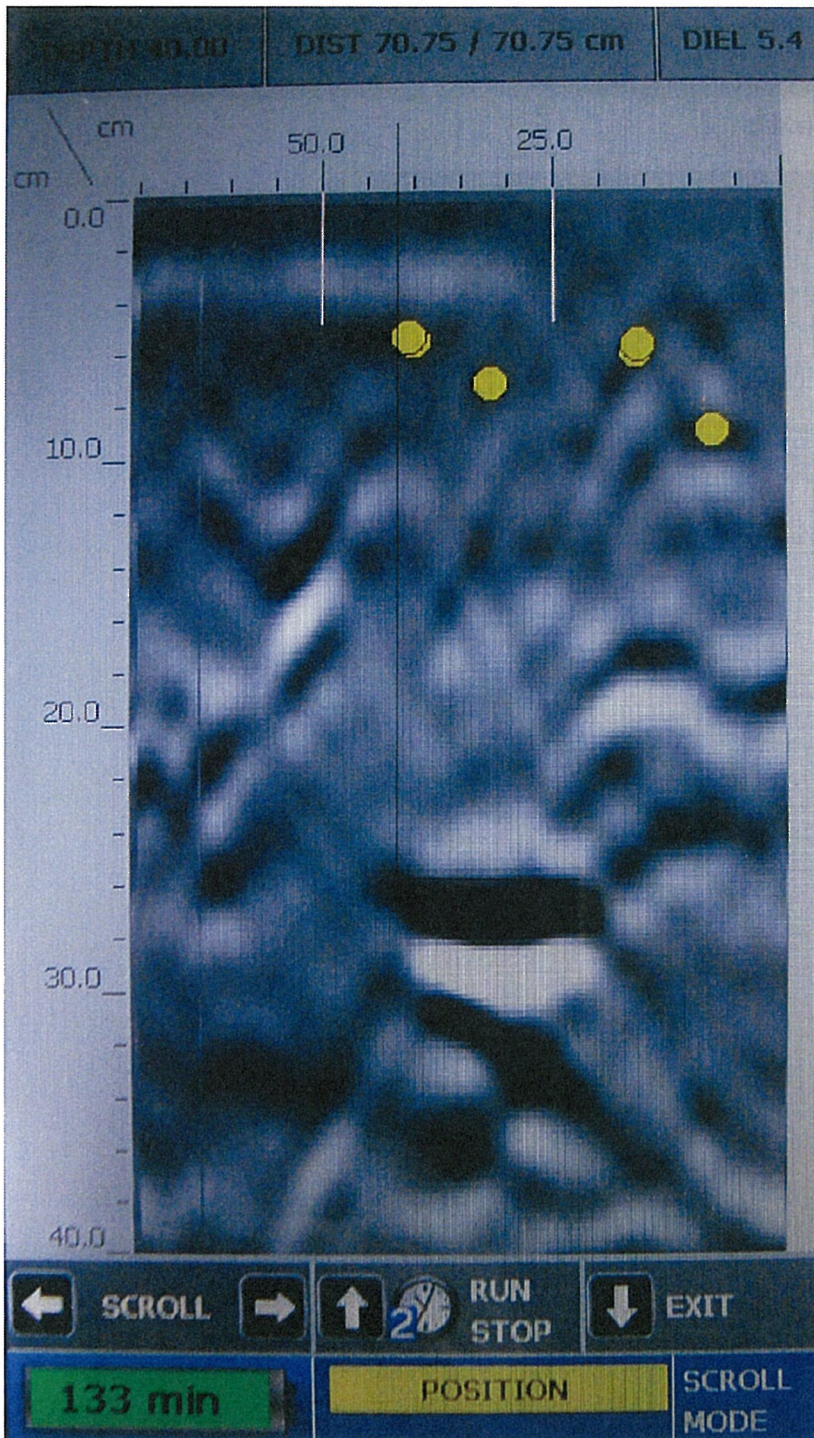
At floor joist level and in the lintel area above the windows, strong steel reflections were observed.

Image 10. Vertical extent of plate at floor joist level.

Further minor investigative work should be conducted to ascertain the interior construction between floor levels. This would be simple enough to achieve given a detailed methodology.

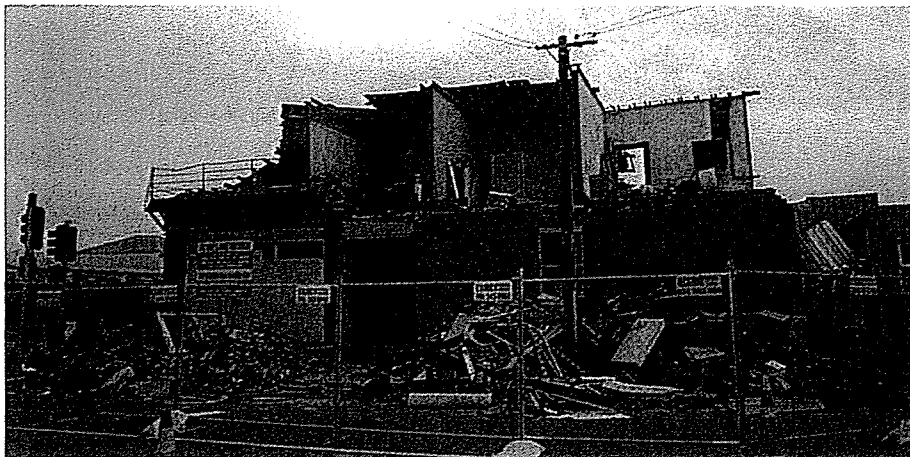
The north wing and the northeast corner have completely collapsed above the first floor, with the first two bays of the east facade having collapsed into the street. The lower level has remained mostly intact along the north facade, although it has sustained damage below the floor level, and is severely cracked in parts. The remainder of the east facade above the first floor has lost its parapet, and is leaning outwards for at least one bay, by as much as 100mm. This inclination reduces to the south. It appears that the dividing walls between the units may be intact, but no internal inspection was possible.

Figure 1: View from north

We recommend that the building be demolished.

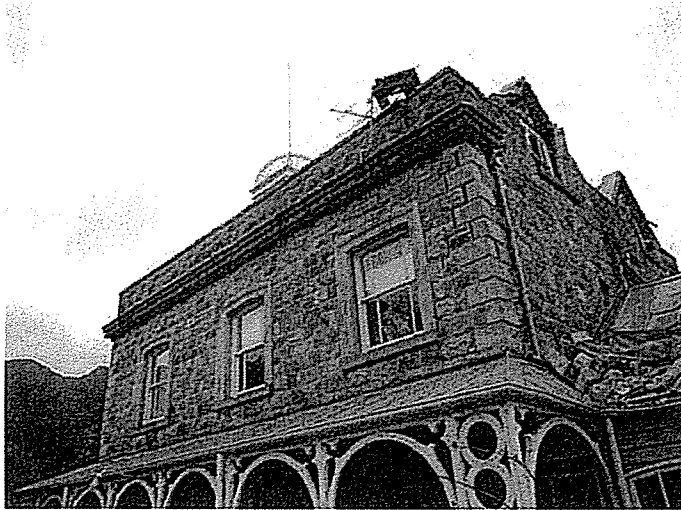
Although there is no existing record of levels prior to the earthquake, it appears that there has been some settlement of the existing foundations.

Figure 1: Northeast corner

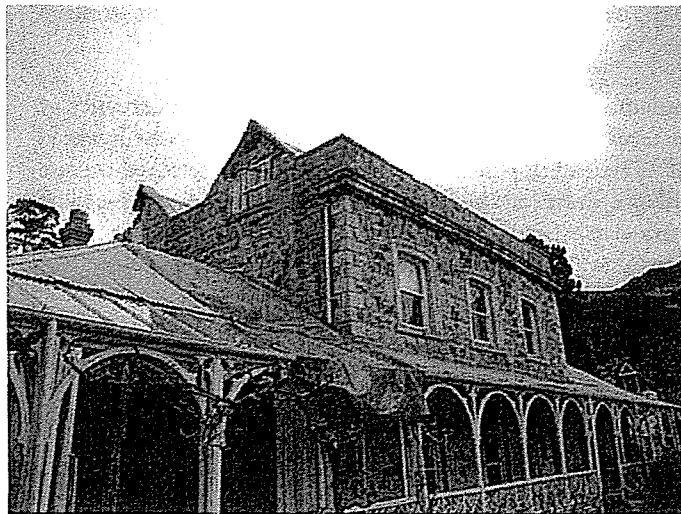
Figure 2: Southeast corner

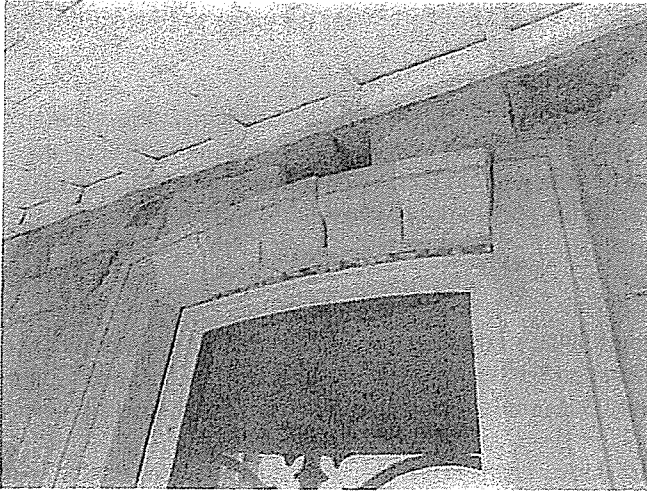
All the window and door heads have shallow stone arch lintels. In most cases, the seismic shaking has caused the arch stones to drop downwards by approx 20 to 25mm which has in turn caused the wall sections to be pushed sideways and stones immediately above the lintel arches dropping down or in one case, falling out of the wall. Individual jamb stones to windows and doors had displaced sideways by up to approx 20mm.

Window lintel arches fell approx 20mm displacing stones above and walls alongside

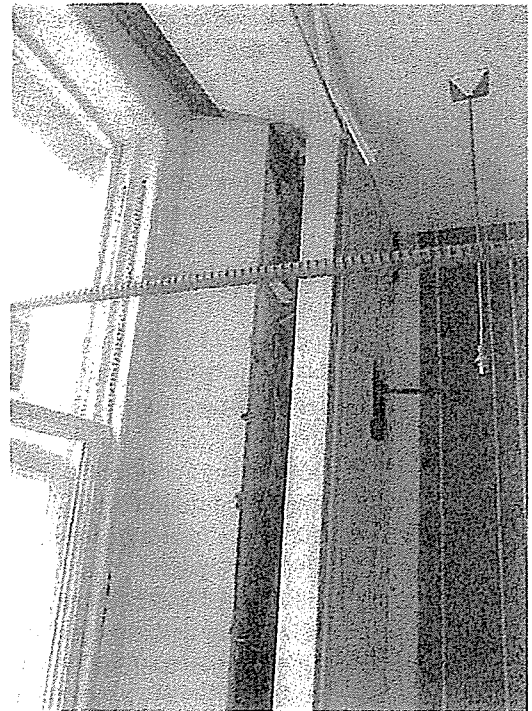
2. The stone north face at ground and first floor has bowed out by 100mm. The heads of the two ground floor windows and the door up to the sills of the first floor windows are severely cracked with the worst damage in the north east corner. The central voussoir in the east ground floor window in one of the after shocks fell out and smashed the floor of the verandah. The first floor cornice, though held by the steel tie, has bowed out. The parapet held by the ply strengthened roof is straight but cracked.

Approx 100mm outward displacement of north wall

3. The badly cracked and bowed north wall will have to be carefully demolished with dressed and moulded stones of the jambs and head of the one door and two windows, the dressed quoins, and the courses around the windows other than 300mm high separately identified the whole rebuilt to the level of the window sills as described in 2 above.
