# **CHRISTCHURCH CITY COUNCIL AGENDA**

## **EXTRAORDINARY MEETING**

**MONDAY 4 OCTOBER 2010**

**4. PROPOSED DEMOLITION OF 160 MANCHESTER STREET**

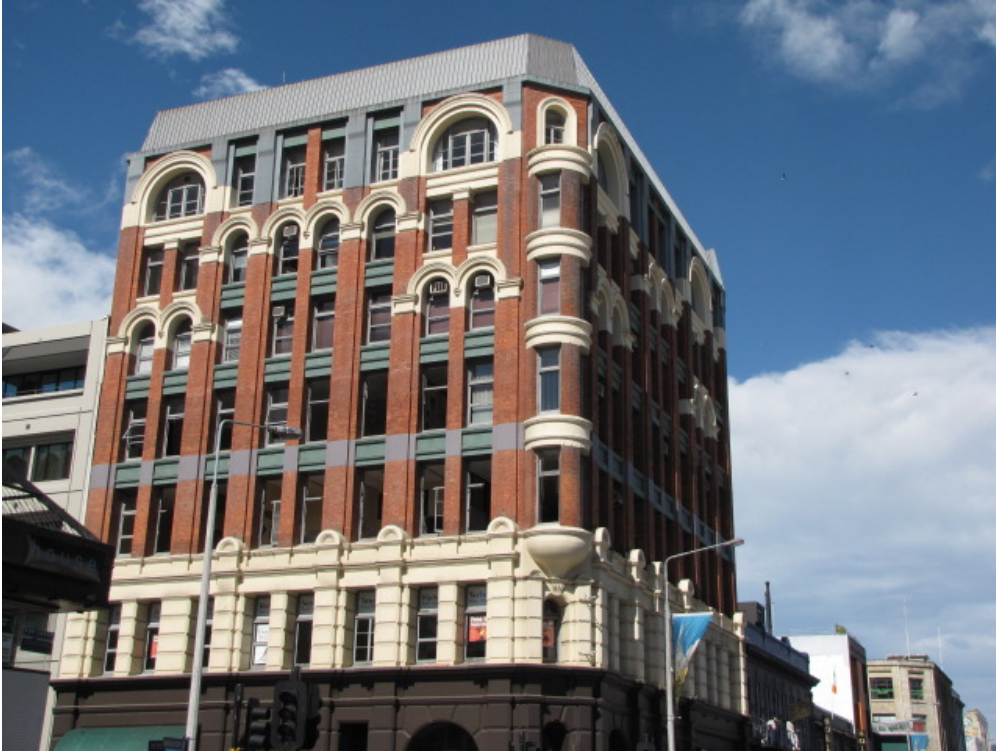
North façade

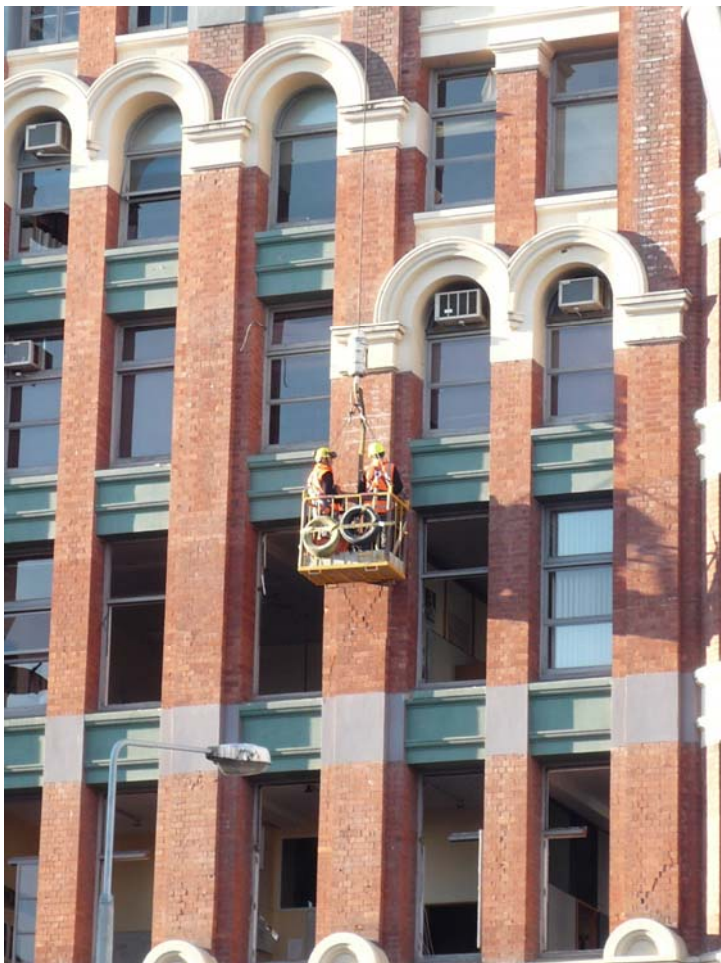
North façade – radar survey being undertaken

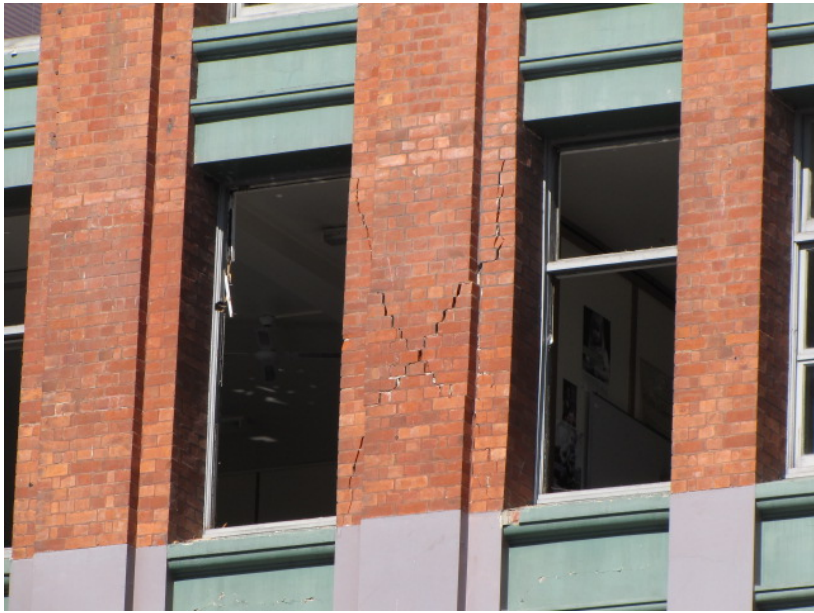
7. Manchester Courts was assessed as 'unsafe' shortly after the earthquake following an external assessment of the building. Urban Search and Rescue undertook work to make the building safe on 7 September 2010. Transverse cracking is visible on all elevations, with crucifix cracks evident on the north and west facades. Barriers have been set up around the building with a cordon of approximately 100m. There are up to 7 buildings within the inner cordon, but buildings are affected for the blocks between Hereford Street and Worcester Street and Hereford Street and Cashel Street, as well as part way along Hereford Street, east to Liverpool Street and west to Tramway Lane and partly beyond.

**Transverse cracking on north façade**

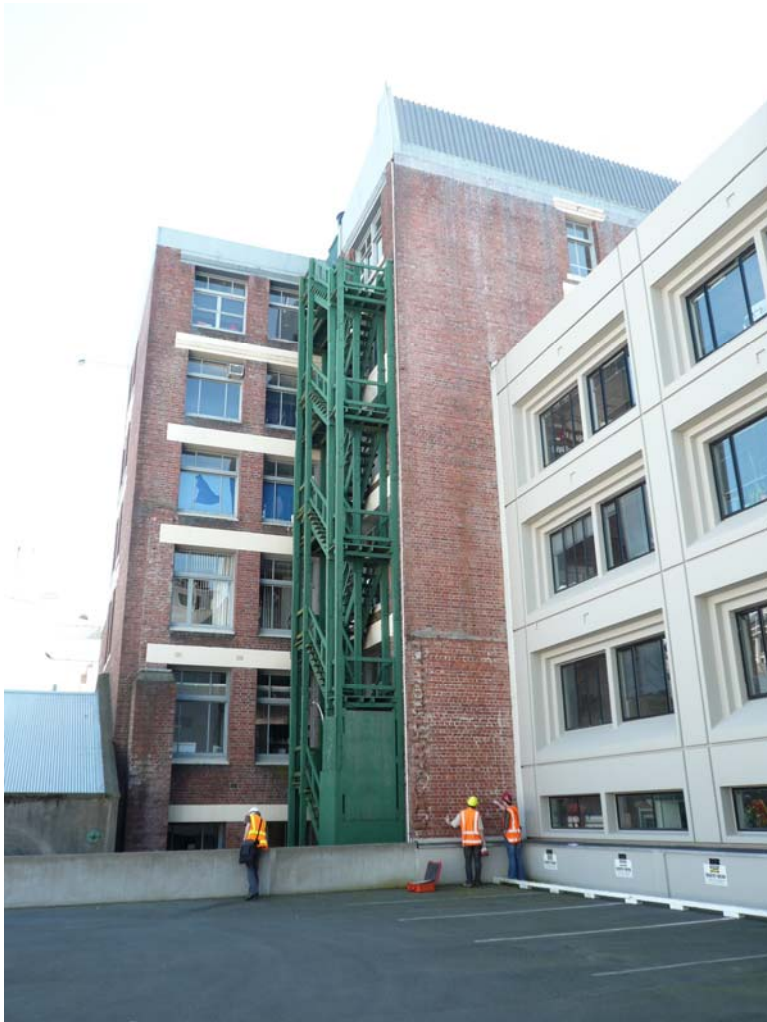
**Rear of property, east façade**

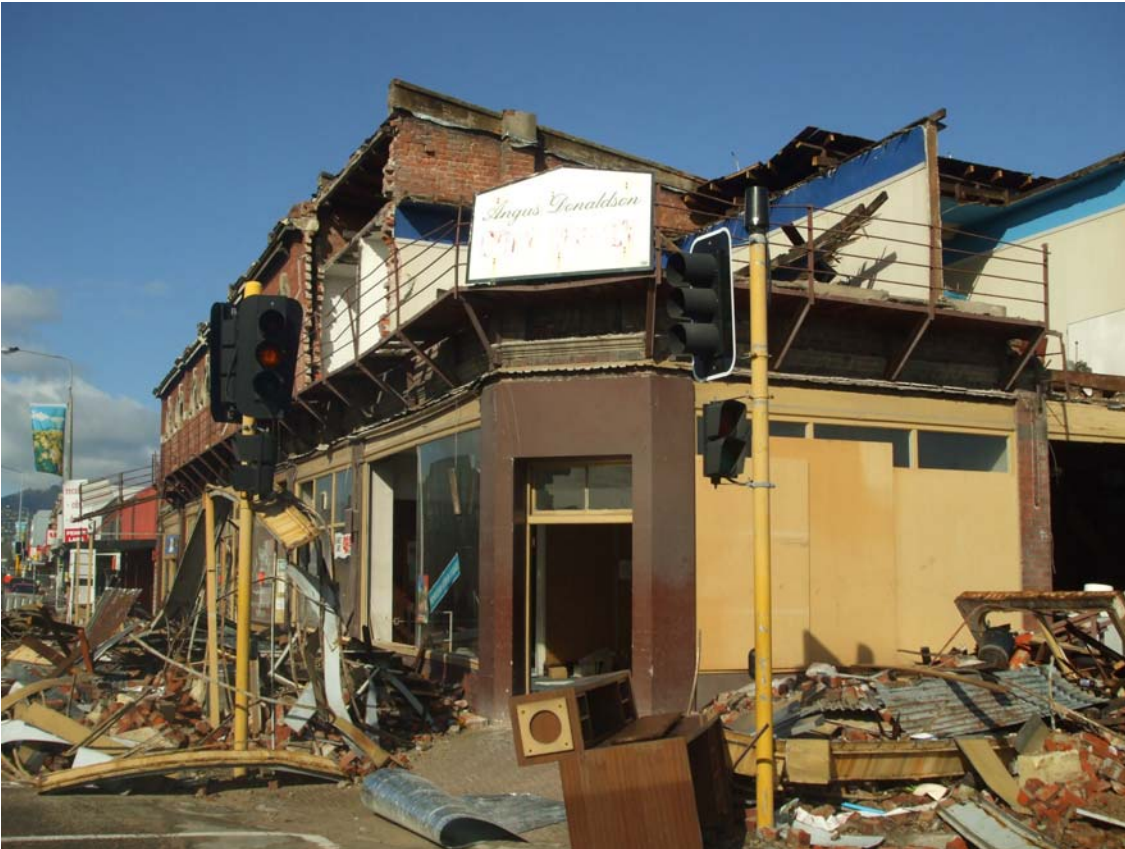
6. The frontages on the corner of Colombo and Sandyford Streets have been severely damaged and the upper floor walls in this area have fallen out. The bullnose verandah has fallen off and the parapets along Colombo Street are damaged and unstable.

Corner of Colombo and Sandyford Streets

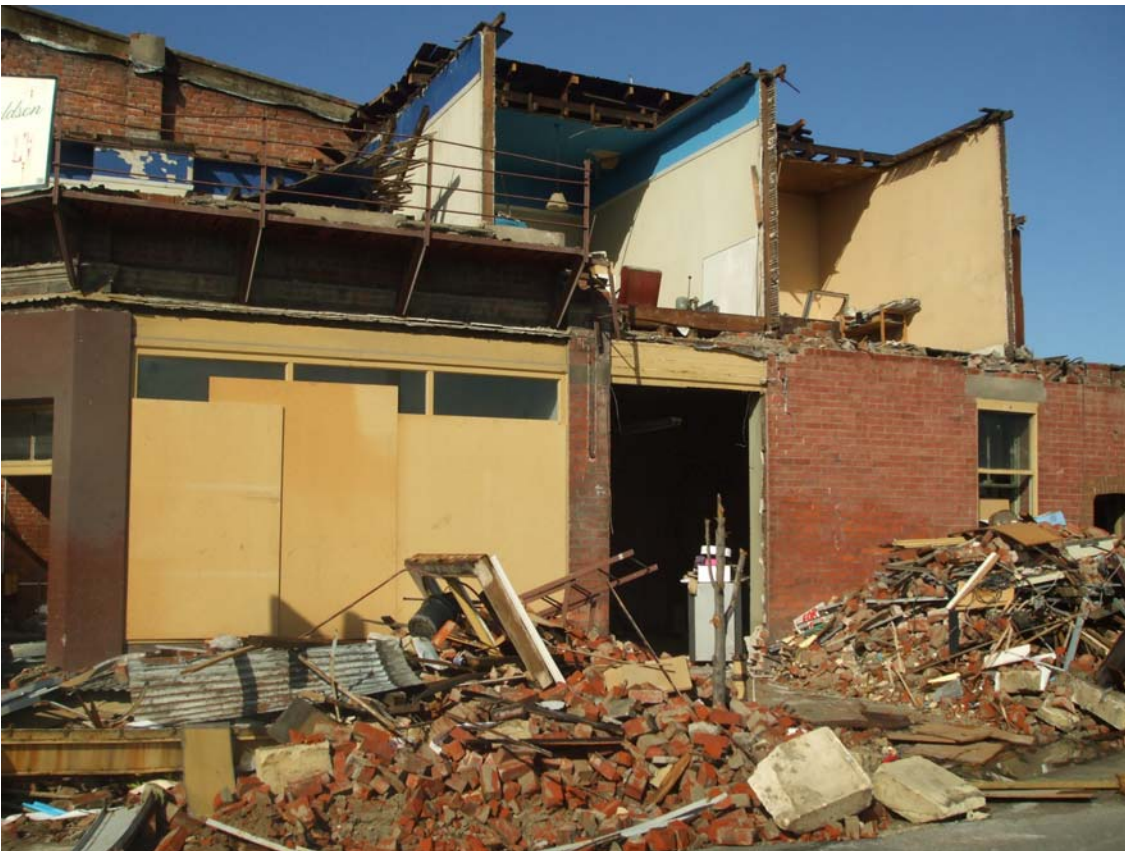
Sandyford Street frontage

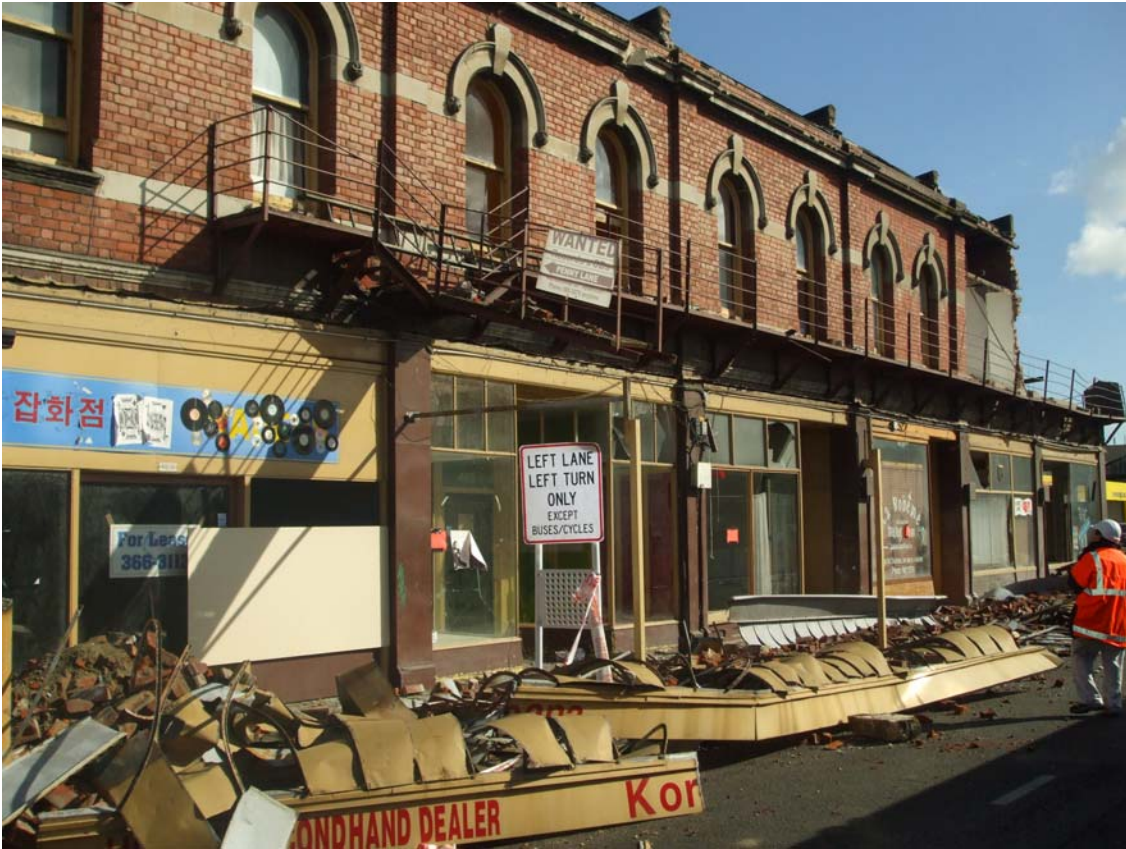
Colombo Street frontage

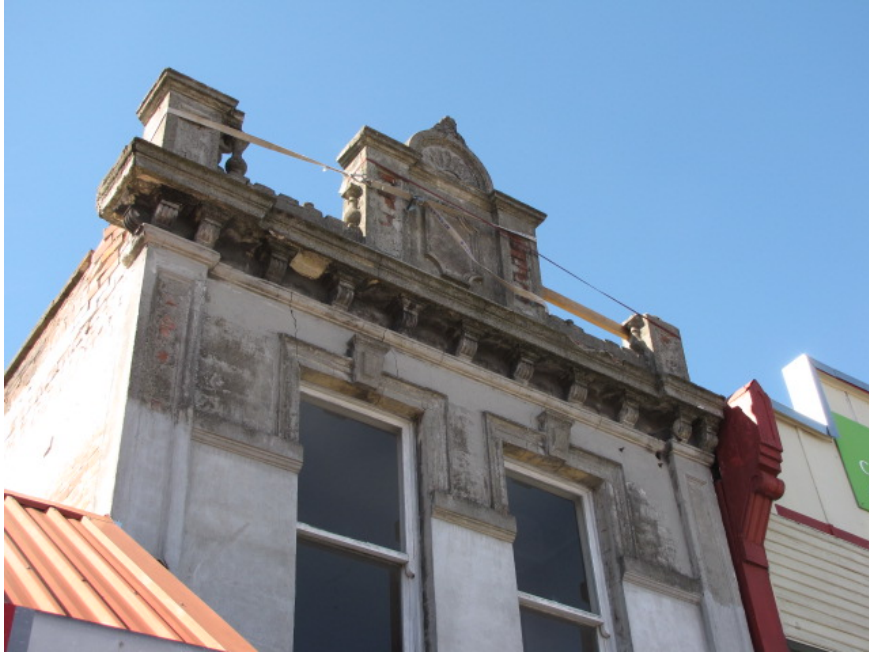
Figure 1: View of ornate parapet that has been damaged

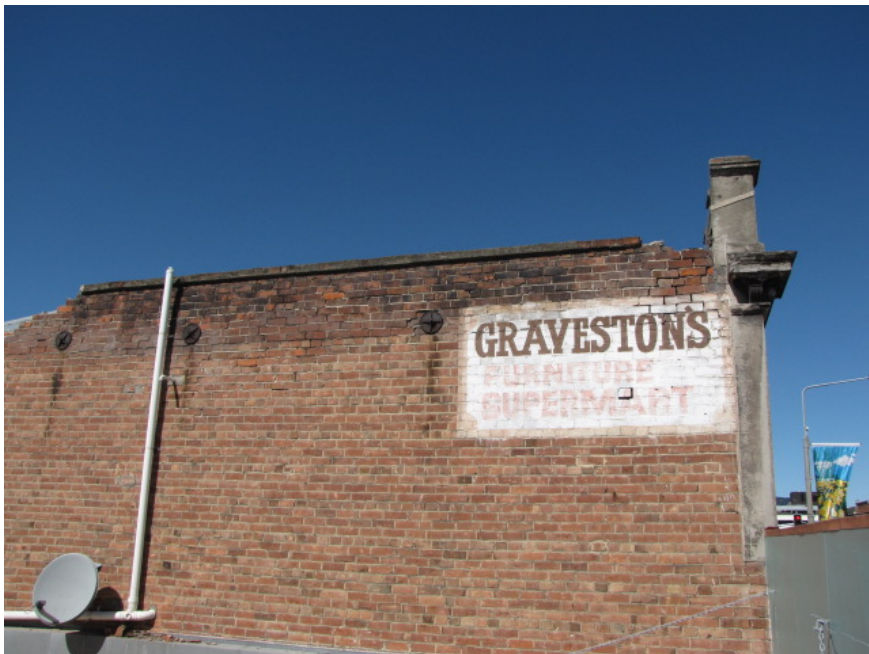
Figure 2: damage to brickwork

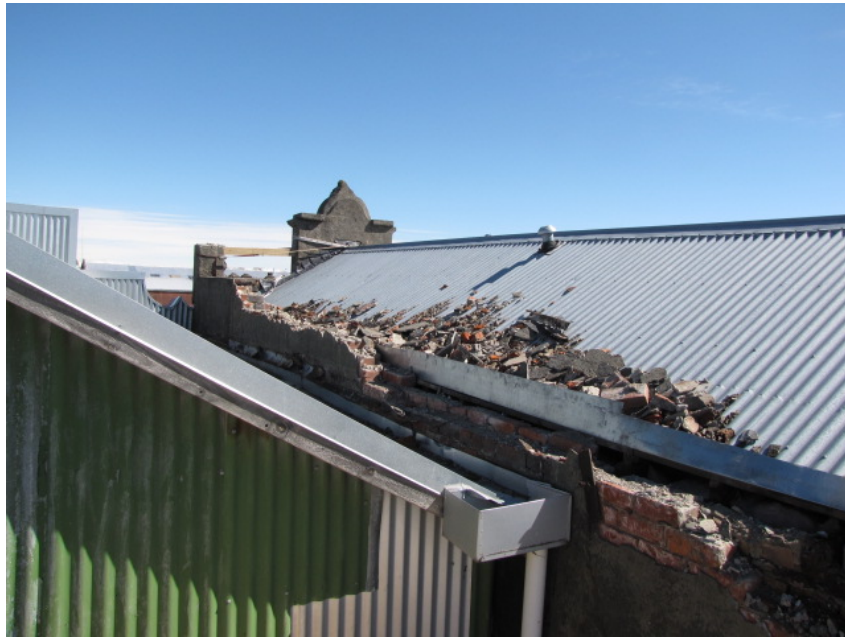
**Figure 3: damaged firewall**

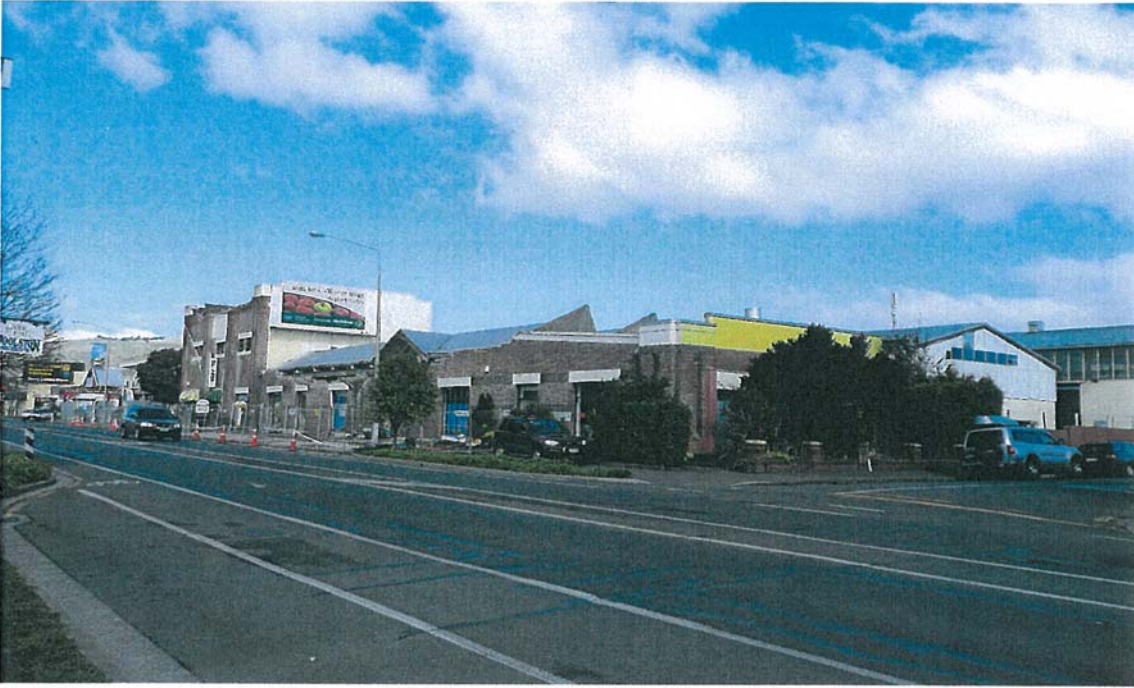
From Ferry Road, Ferry Road - Heathcote Street corner

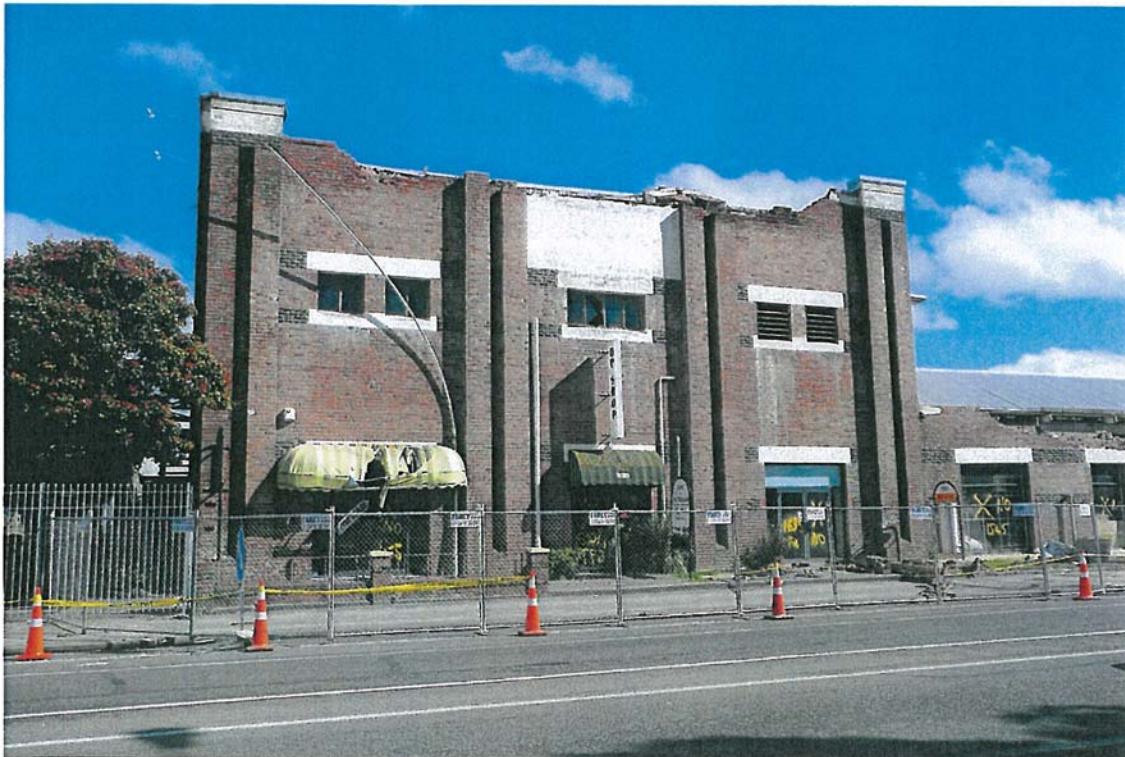
North Wall two storey Building

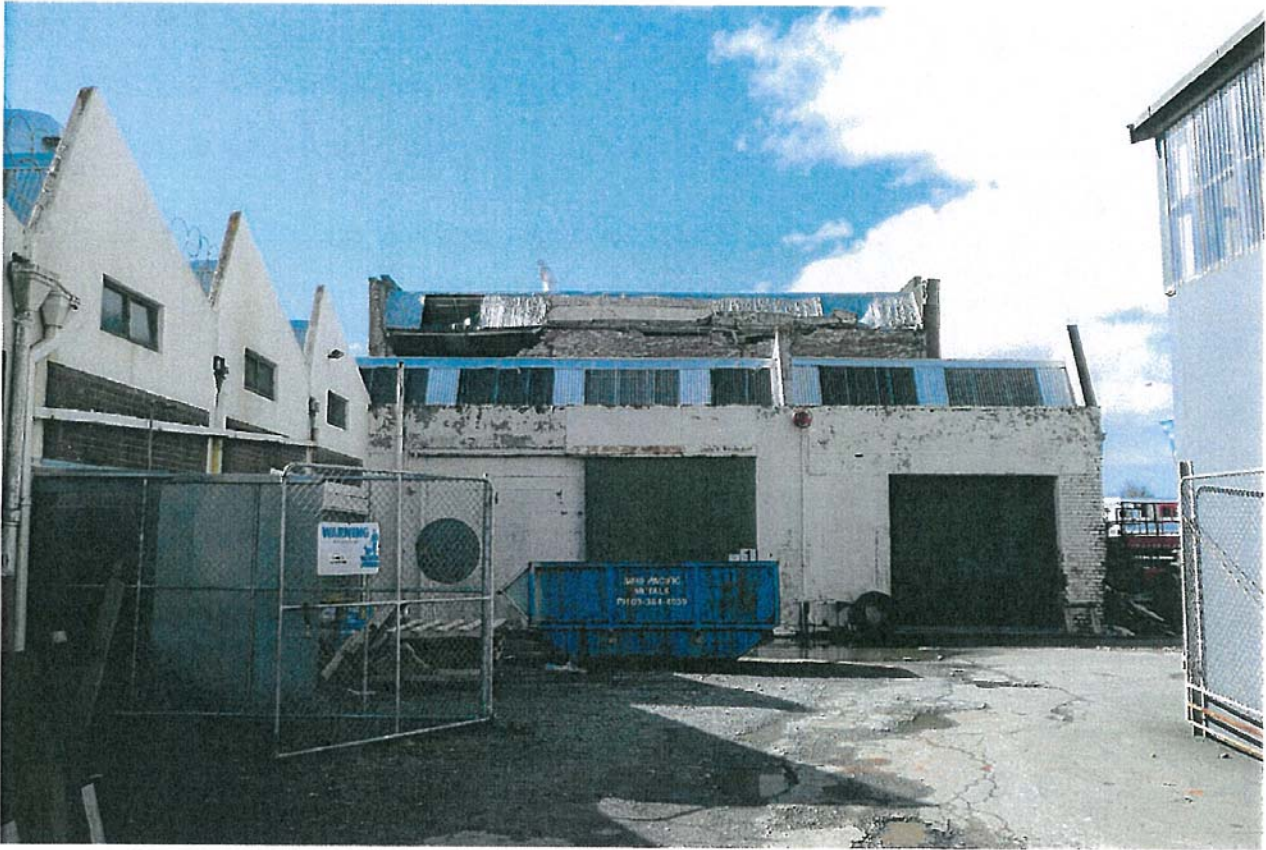
**South Wall Two Storey building**

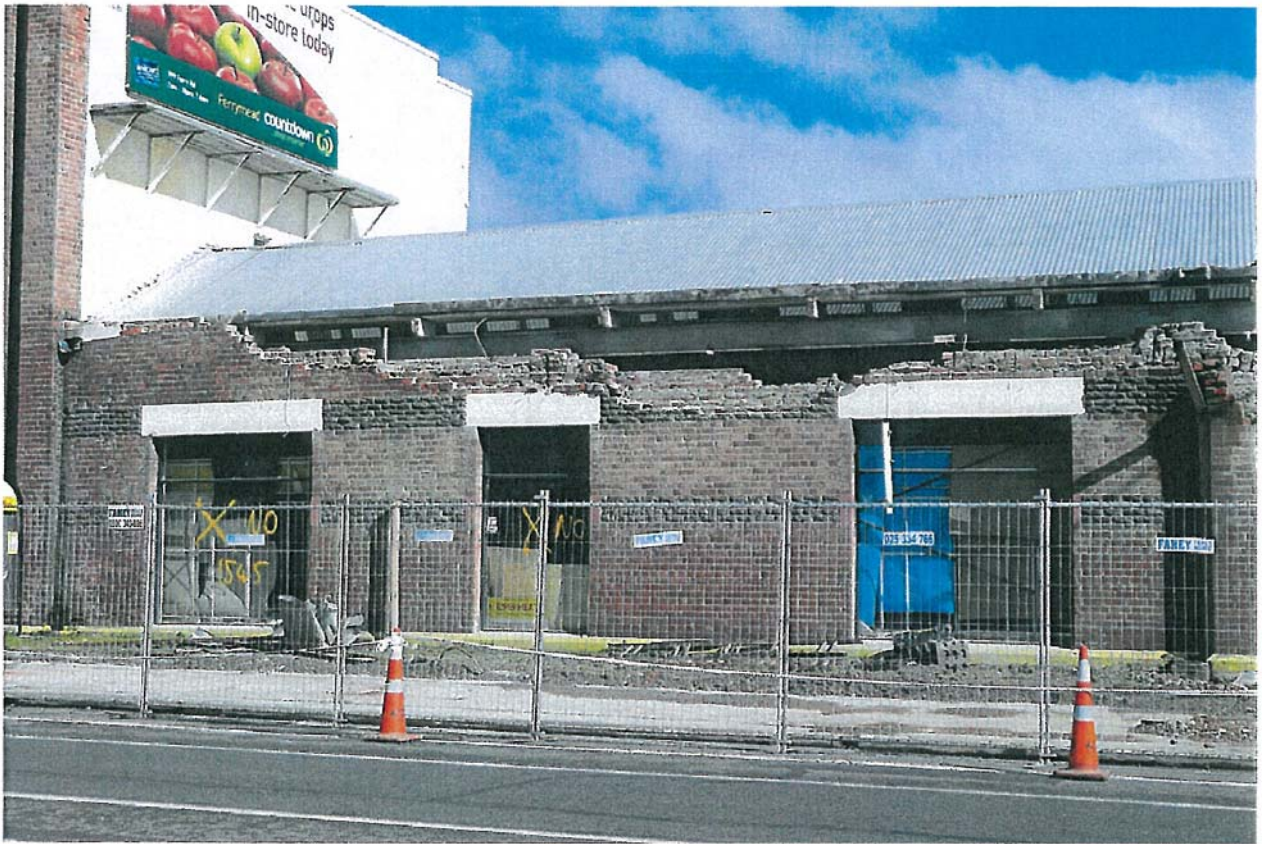
**North Wall single storey section**

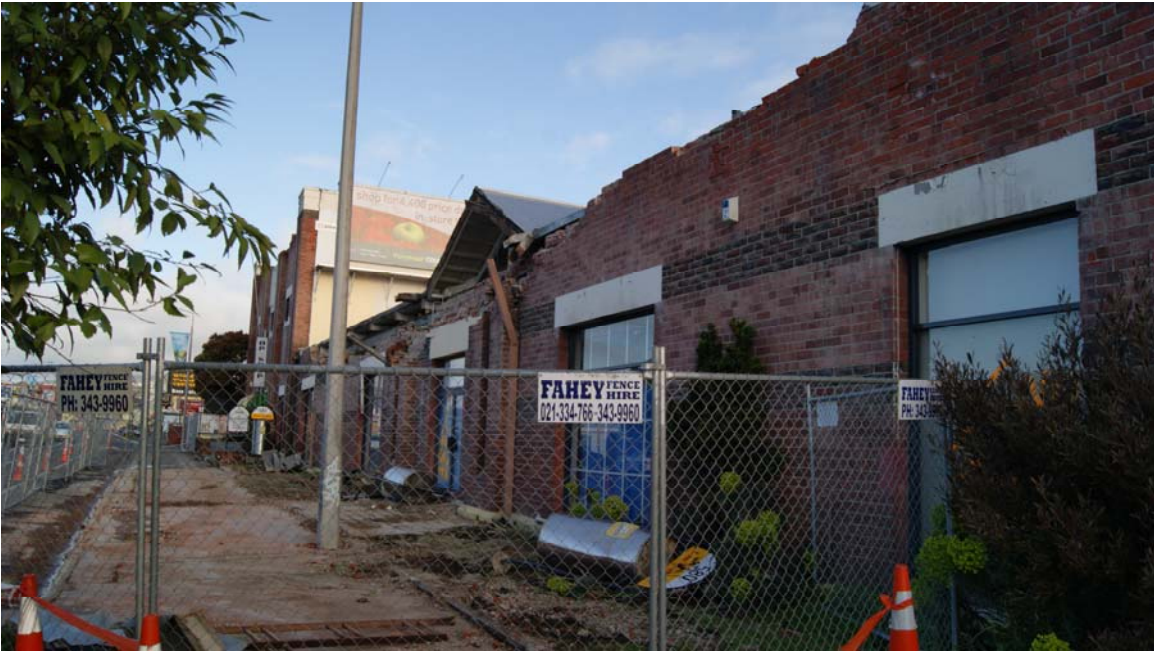
North Wall single storey section

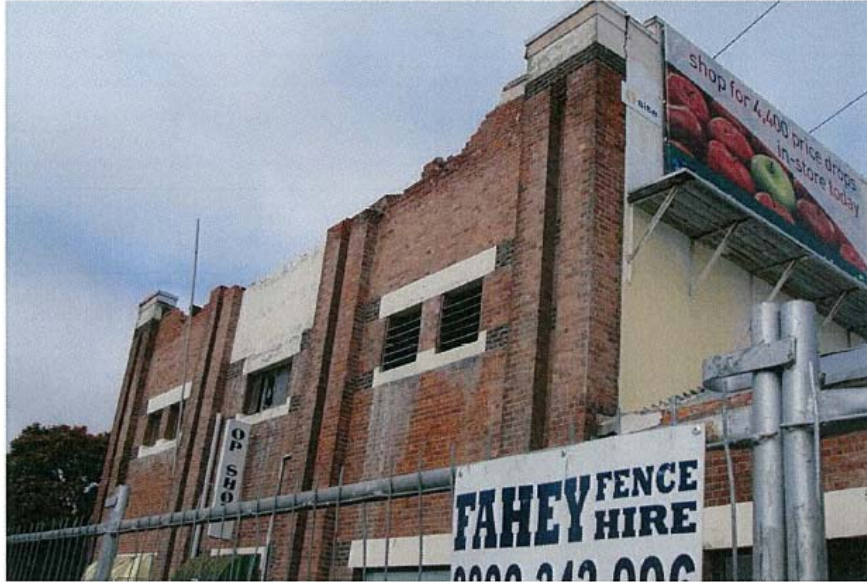
**PHOTO 1 – TWO STOREY PART A – NORTHEAST FACADE – EXTENSIVE  
PARAPET AND WALL DAMAGE.**

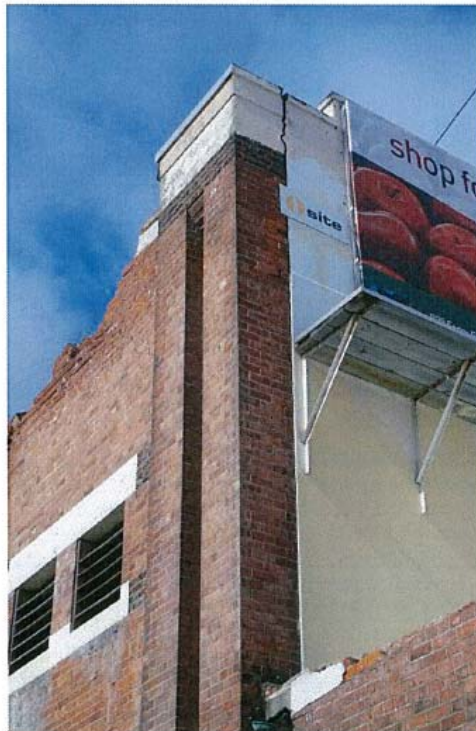
**PHOTO 2 – NORTH CORNER SEPARATION AND PARAPET DAMAGE.**

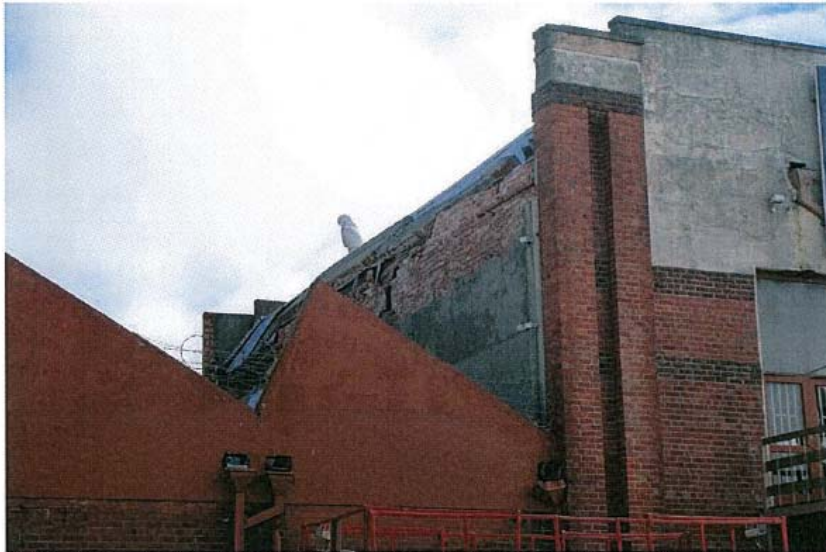
**PHOTO 3 – 2 STOREY PART A – SOUTHWEST PARAPET AND WALL DAMAGE.  
LOSS OF CORNER RESTRAINT TO NORTHWEST AND SOUTHEAST  
PARAPETS AND WALLS.**

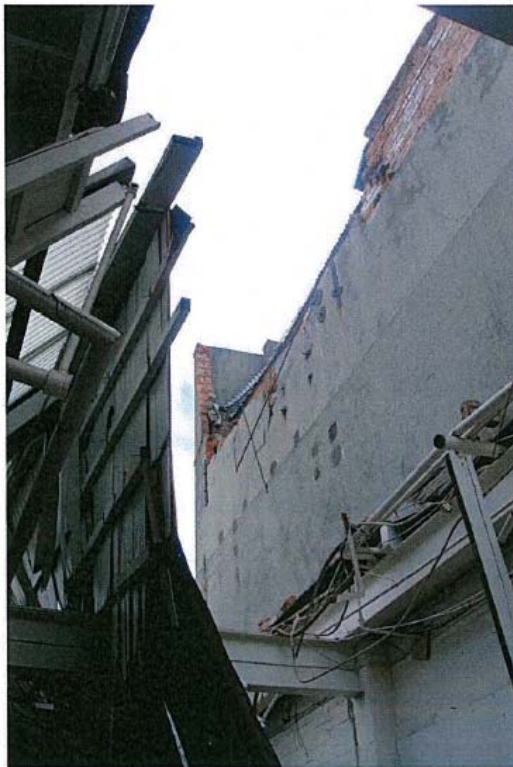
**PHOTO 4 – 2 STOREY PART A – SOUTHWEST PARAPET AND WALL DAMAGE.  
ROOF DAMAGE TO PART C1.**

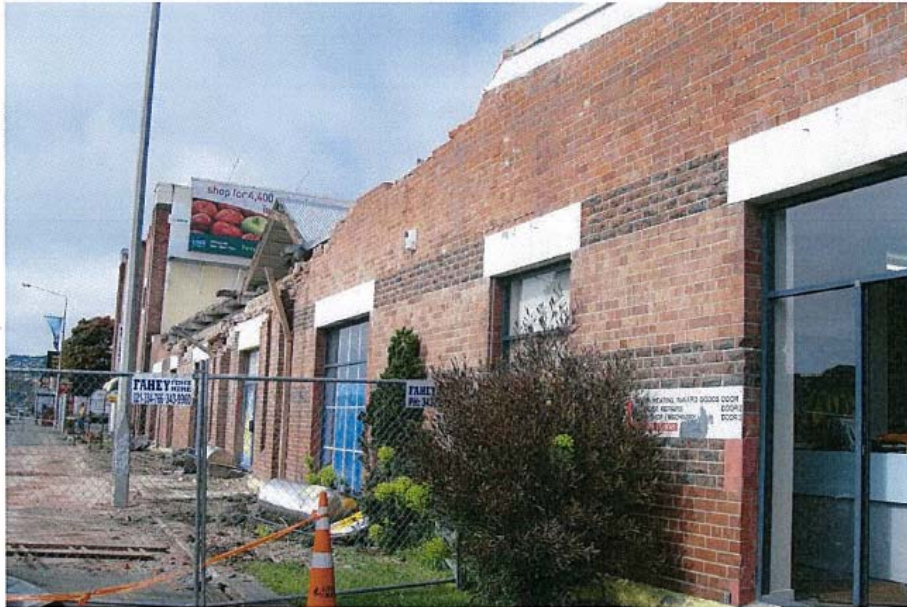
**PHOTO 5 – SINGLE STOREY PART B – EXTENSIVE FACADE DAMAGE TO PARAPETS AND WALL. LOSS OF ROOF SUPPORT.**

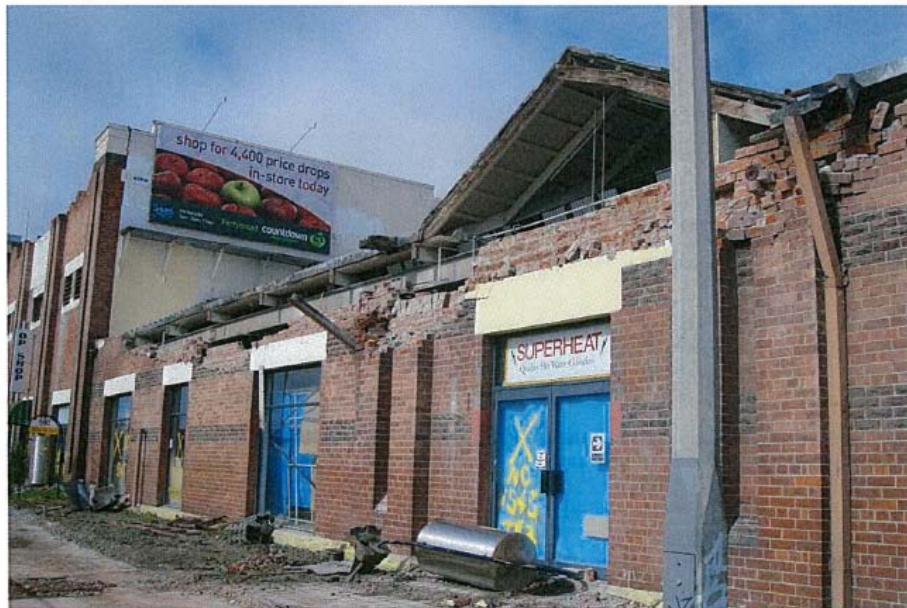
**PHOTO 6 – SINGLE STOREY PART B – EXTENSIVE DAMAGE TO PARAPETS AND WALLS  
LOSS OF ROOF SUPPORT AND TIES TO WALLS**
