13. FACILITIES REBUILD PROJECT - FENDALTON LIBRARY AND SERVICE CENTRE

1. To seek approval to proceed with the permanent repair of earthquake damage at Fendalton Library and Service Centre, strengthening works identified by the Detailed Engineering Evaluation (DEE) of the building's structural strength (relative to the New Building Standard) and asset enhancement work required to mitigate a recently-identified health and safety hazard.

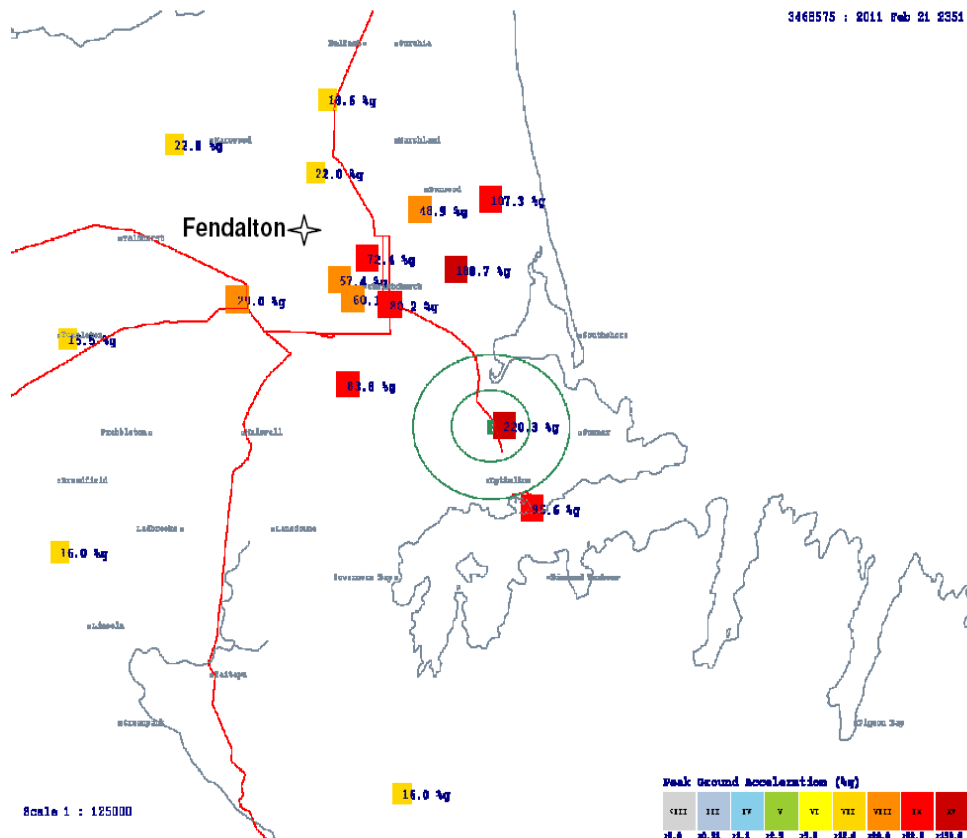
29. The Fendalton Library and Service Centre incurred modest visible damage from the September 2010 and subsequent earthquakes. The February earthquake's ground accelerations in this area was significantly less than those experienced in the central city (see below) and the resulting damage to wall linings and fixtures was largely cosmetic. Some cracking damage and opening up of expansion joints was also evident in the concrete floor however the extent of this was difficult to assess while the facility was being used by a large number of staff.

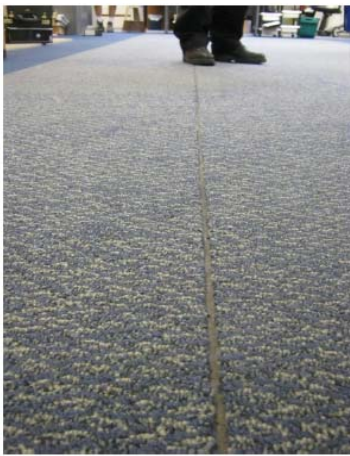
Photo 1: 25 March 2011

40. Vacating the space also facilitated intrusive investigations of the floor cracks which revealed that expansion joints and saw cut construction cracks (as provided for in the original design) had widened beyond their intended design and that new cracks had appeared. The facility has been occupied continuously since opening in 1998 with the original carpet still in place and no obvious signs of gaps in the concrete floor or carpet wear and tear along these lines existed prior to the earthquakes. Accordingly, this movement has been attributed to the impact of the earthquakes and staff believe the cost of flooring repairs are claimable under Council's insurance policy. Allowances have been made for some carpet replacement as a result of the floor slab repairs.

41. The building's structural design relies on the concrete floor slab contributing to the bracing of the building's portal frame structure. Key to the integrity of the concrete floor is the steel mesh reinforcing, which has been compromised due to the impact of the earthquake. As a result some areas require additional reinforcing ties to reinstate structural integrity of the building.

The cost of repairing and reinstating the structural integrity of the floor slab is approximately \$51,000, including an allowance to reinstate the carpet and other floor coverings as required.
