542/791

1. LINWOOD GLOUCESTER PROPOSED TRAFFIC SIGNALS

11. GLOUCESTER STREET/LINWOOD AVENUE TRAFFIC SIGNALS

POST CONSTRUCTION ROAD SAFETY AUDIT

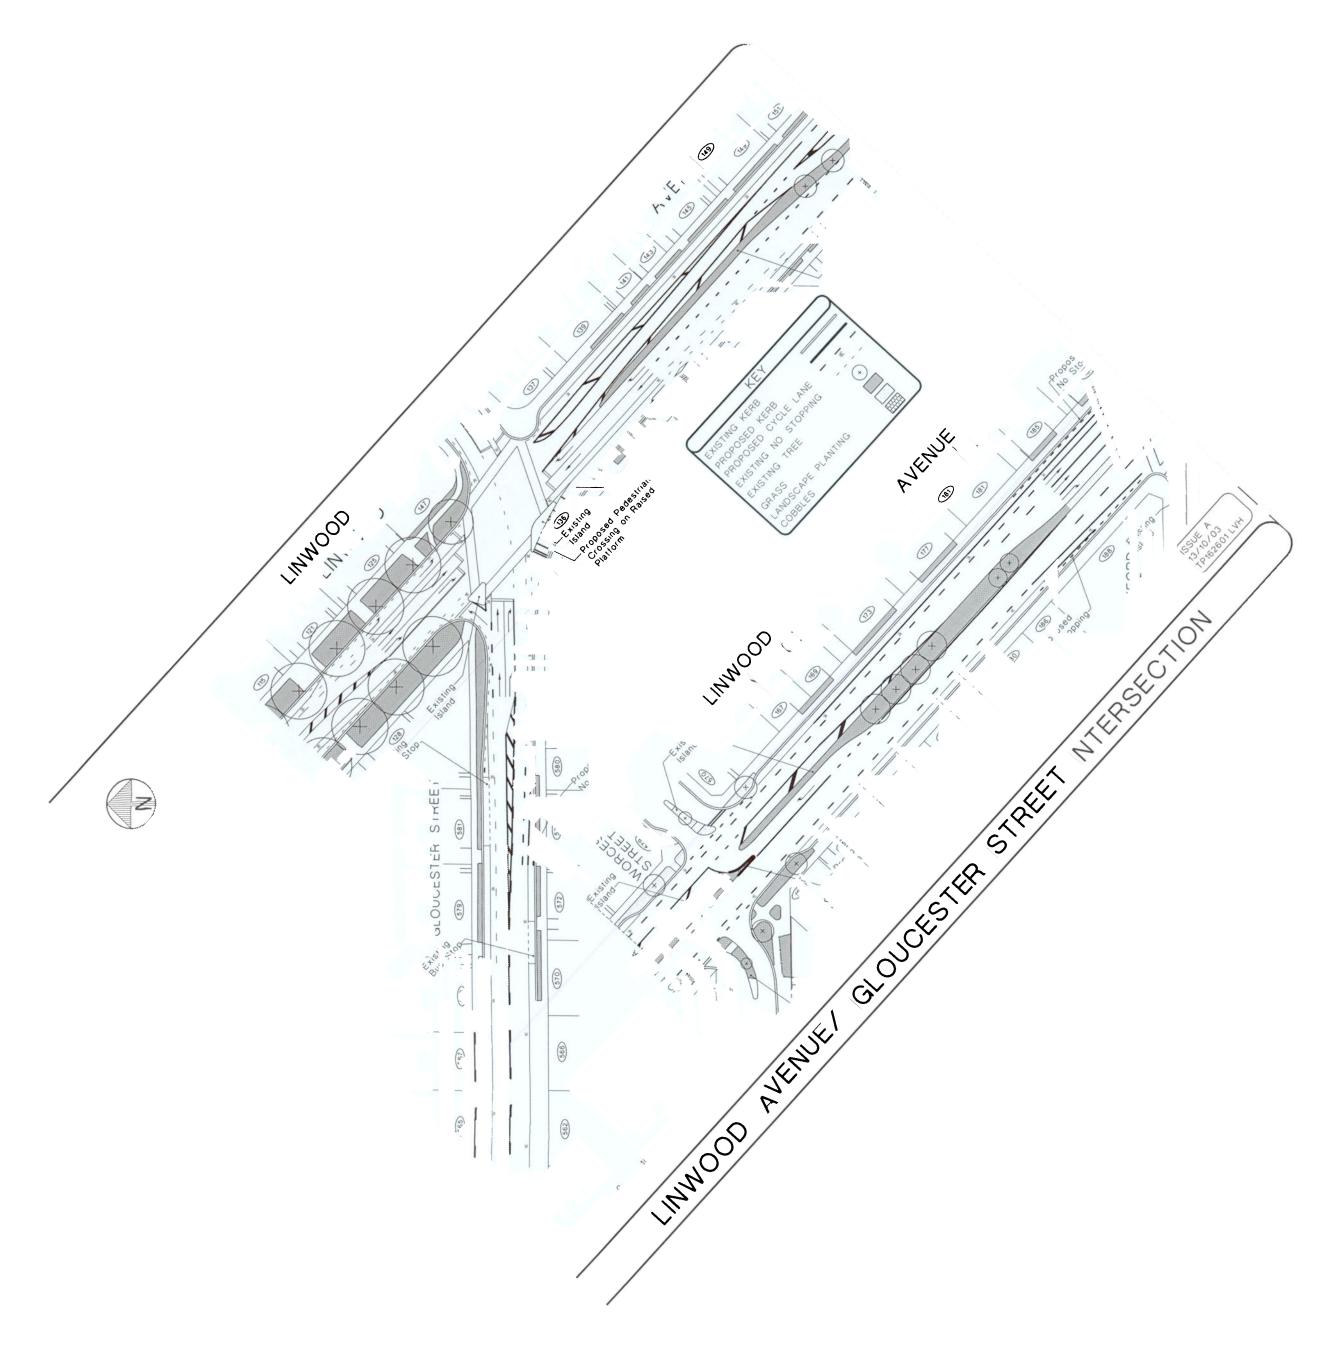
ROAD MARKING PLAN

Arrangements are being made to implement the attached road marking plan. The plan proposes to limit the flow of traffic between Gloucester Street and Hereford Street to one lane in each direction with improved right turn facilities at the Worcester Street intersection. Cycle lanes will be extended along Linwood Avenue to Hereford Street.

With the elimination of two lanes of traffic in favour of a single lane through this section of Linwood Avenue, pedestrians will find it easier to cross Linwood Avenue at the Worcester Street intersection. Pedestrian safety will also be enhanced if a proposed "zebra" pedestrian crossing is installed on a raised platform within the left turn slip lane from Linwood Avenue into Gloucester Street west.

- 1. That the information be received.
- That the Board support the traffic management proposals for the section of Linwood Avenue between Gloucester Street and Hereford Street.
- That a "zebra" pedestrian crossing be installed within the left turn slip lane from Linwood Avenue into Gloucester Street west. The pedestrian crossing will link with an existing pedestrian/splitter traffic island and the footpath on the south-west corner of the intersection outside No 136 Linwood Avenue.
