**5. PARKING PROPOSALS - MAIN ROAD**

**PURPOSE OF REPORT**

1. The purpose of this report is to seek the Board’s approval for the installation of “no stopping” restrictions on the Estuary side of Main Road between Scott park and the west culvert.

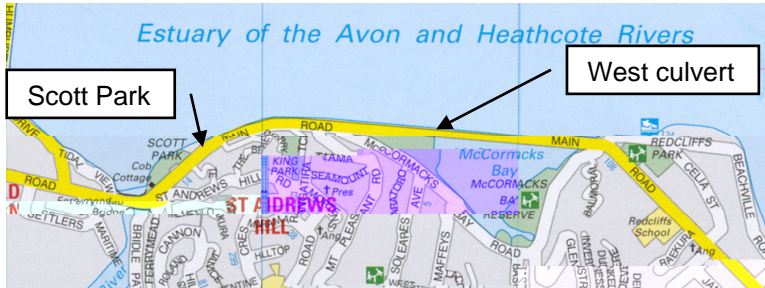
3. The Estuary seawall is a continuous structure, approximately 1,700 metres long, constructed of large angular stones and concrete blocks held together by unreinforced concrete and mortar. A visual inspection has found many areas of the Estuary seawall in need of repair. The area of repair is contained in the first 1,000 metres from Scott Park to the west culvert at the start of the Causeway. The balance of the Estuary seawall to Beachville Road is in reasonable condition and does not pose a risk at this time.

4. The cause of the damage to the Estuary seawall is foreshore erosion. This erosion has undercut the wall and has led to the damage and risk to the seawall and shoulder. Parts of the Estuary seawall have cracked and slumped due to the erosion and this has created instability in the road shoulder with visible signs of surface cracks and subsidence behind the wall.
