# **CHRISTCHURCH CITY COUNCIL AGENDA**

## **EXTRAORDINARY MEETING**

**MONDAY 4 OCTOBER 2010**

**4. PROPOSED DEMOLITION OF 160 MANCHESTER STREET**

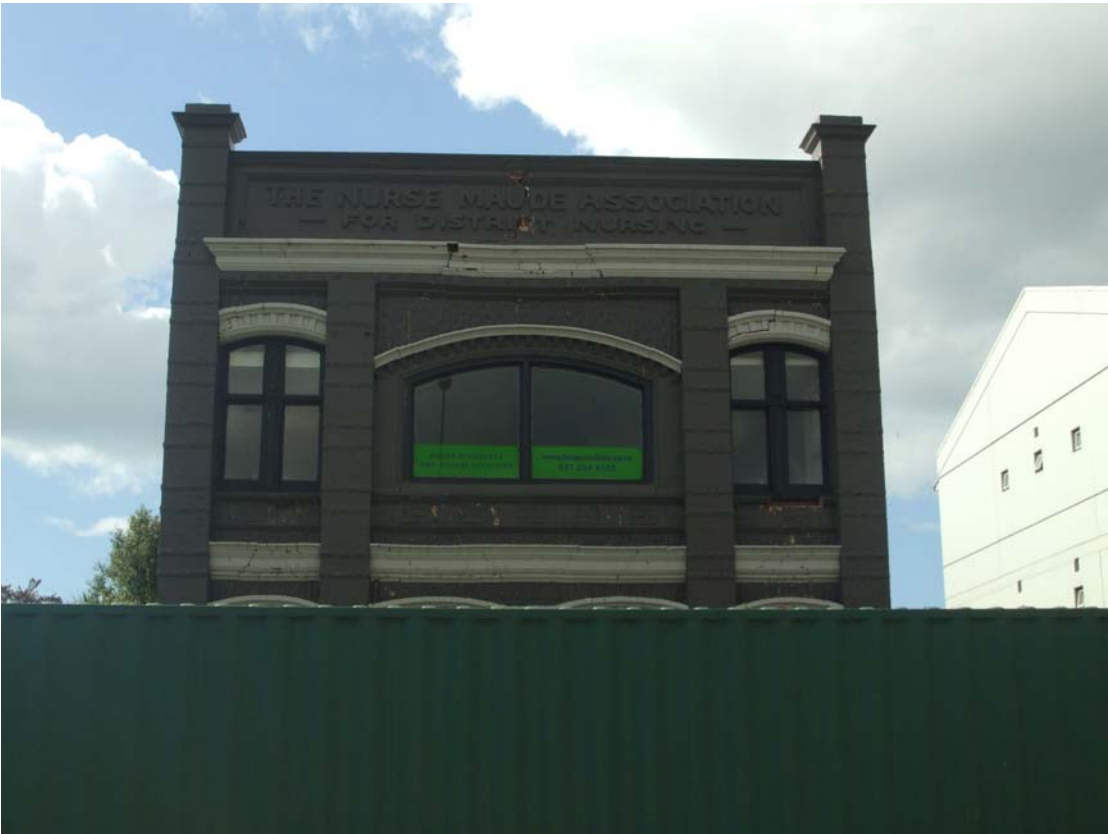
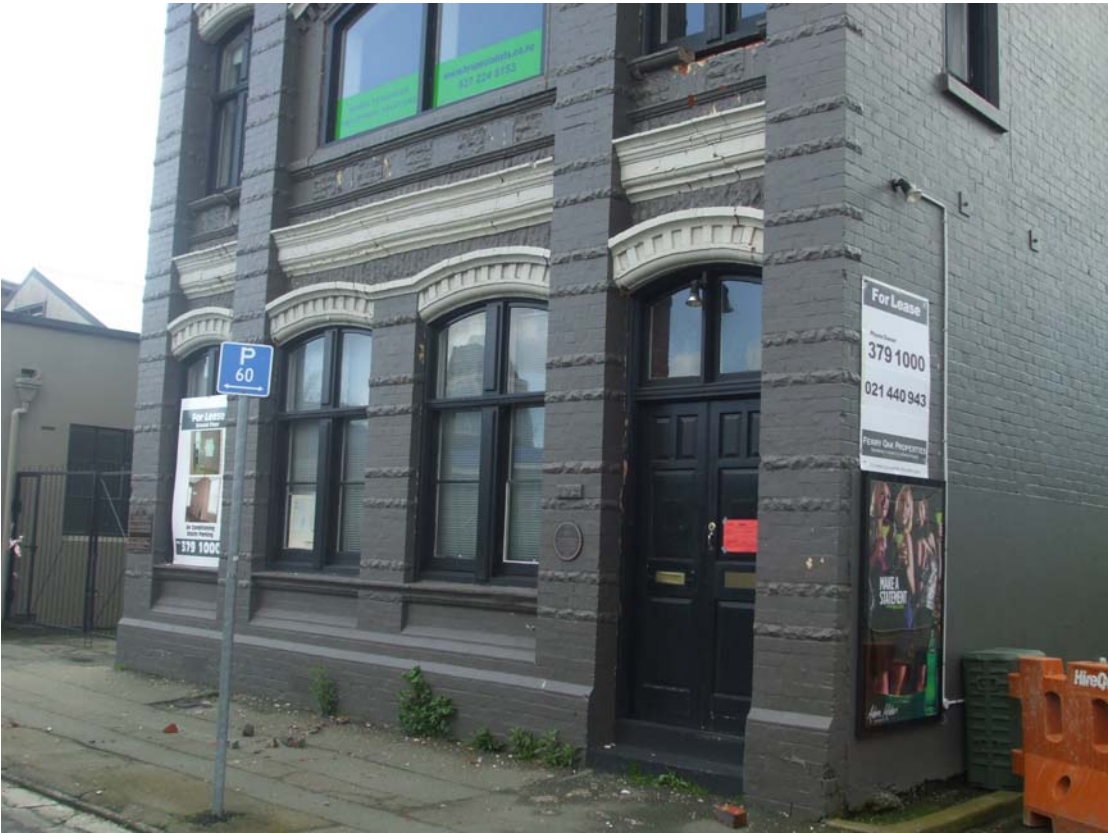
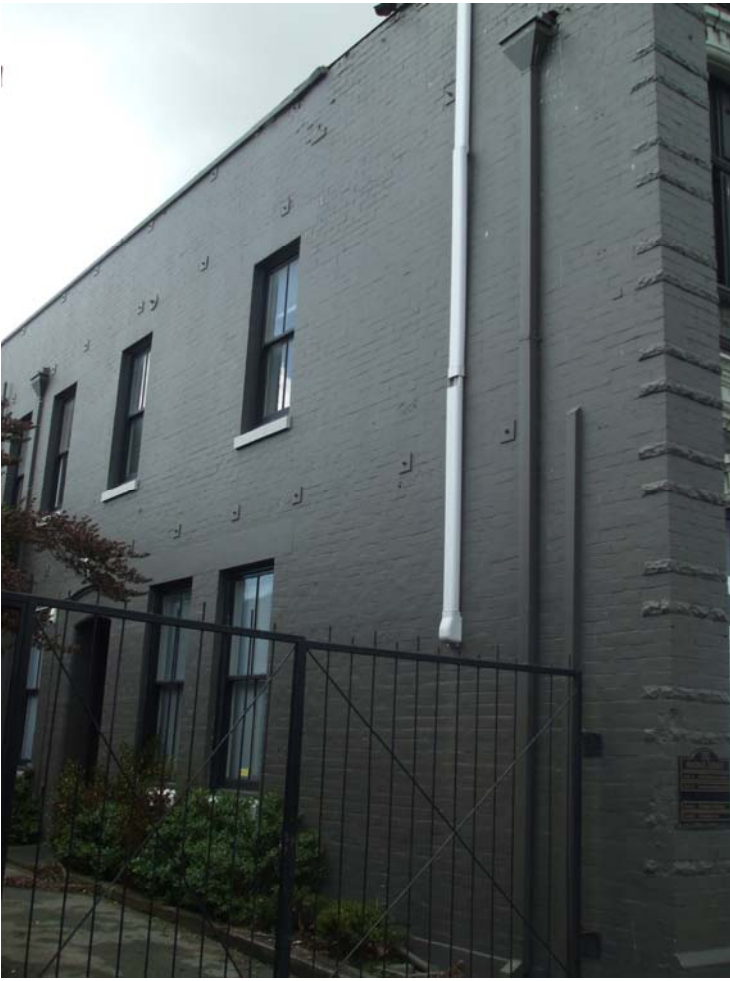
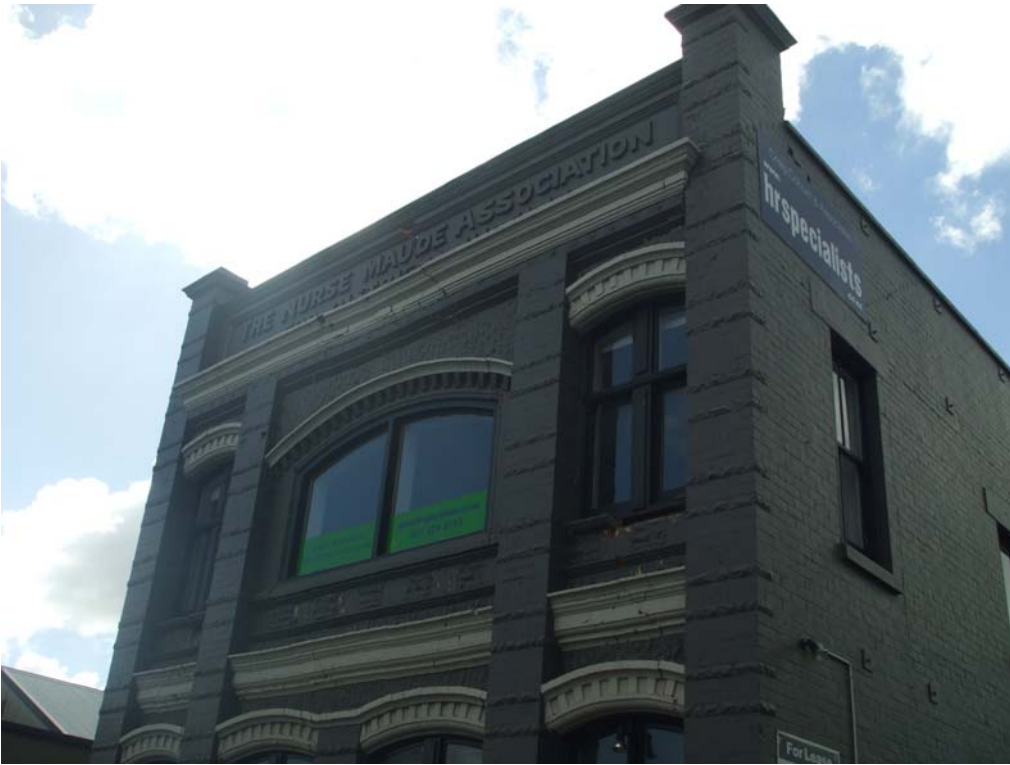
Appendix 3: Photographs

7. The west (front) façade of the building has been severely damaged by the earthquake and cracks are visible on the other three facades. Damage is also visible on the brick parapet on the east side of the building. There is cracking of the internal linings of the building.
